**Mudpuppy (*Necturus*) Survey
at the
Cedar Wapsi (C-57) Bridge
Over the Cedar River
in Black Hawk County, Iowa**

H&A # 1608b

Prepared for
Stantec Consulting Services, Inc.
Independence, Iowa

On behalf of
Black Hawk County Engineer's Office
Waterloo, Iowa

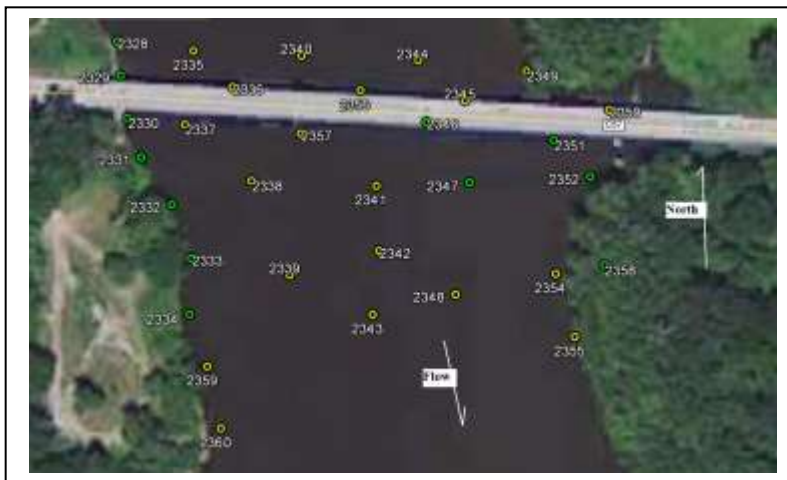
Figure 2. Sampling locations at the Cedar Wapsi (C-57) Bridge over the Cedar River in Black Hawk County, Iowa. Green locations indicate where mussels were found.

The Cedar River at this location has an approximate width of 400 ft. In late June, a mussel survey was conducted in this area (Helms and Associates 2016). That survey extended from 50 ft upstream to 250 ft downstream of the present bridge (Figure 2). The mudpuppy study encompassed a similar area, while concentrating on habitat suitable for mudpuppies.

A preliminary search effort was coupled with the mussel survey conducted June 27 through 29. That survey consisted of both substrate sampling and five-minute timed searches at each of 30 locations (Figure 2). In addition, we conducted a 90-minute search along the entire west bank where substrate consisted of large glacial boulders. These had apparently been placed for bank protection.

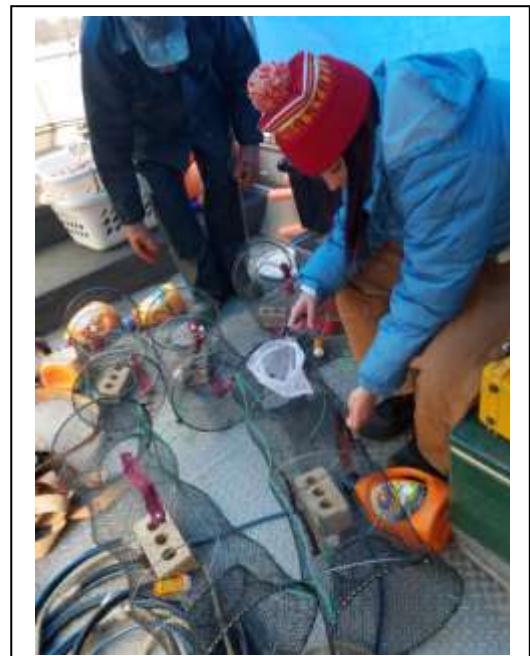
Figure 4. Crew preparing one of 20 traps to set at the Cedar Wapsi (C-57) Bridge over the Cedar River _114718.

Sampling and observations for the mudpuppy study consisted of using traps and visual searches. The traps as shown in Figure 4 were the same (American Maple Promar Minnow Medium Trap: MEDI) as those used by Mr. Hanson in his work at Guttenberg. We used 20 traps baited with minnows, most of which were crushed per Mr. Hanson's instructions.

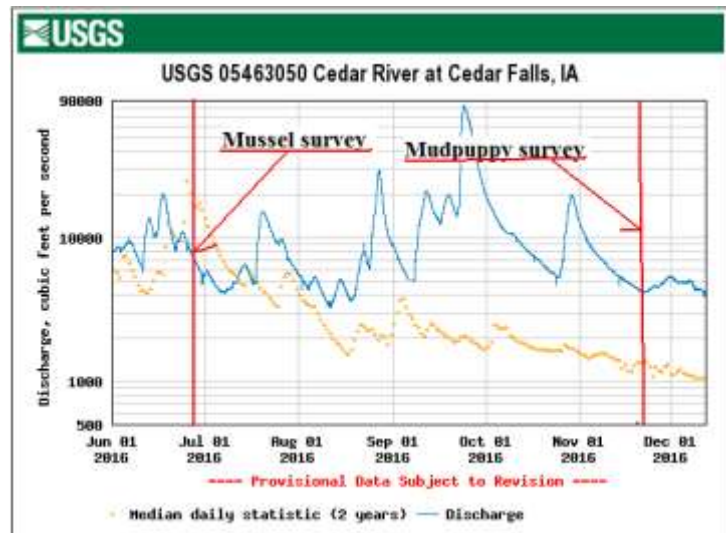
Figure 5. River discharge recorded at USGS 05463050 Cedar River at Cedar Falls, IA during the mussel and mudpuppy sampling by Helms & Associates.

When mussel sampling was completed June 27 through June 29, 2016, discharge ranged between 7,360 cfs and 5,490 cfs, and corresponding gage height was 83.09 feet (846.09 mean sea level (m.s.l.) and 82.14 feet (845.14 m.s.l.). Observed depths ranged from 3.4 to 9.5 feet. Secchi disk readings ranged from 13 to 23 inches. Water temperature was 68 ° F, and air temperature ranged between 68 and 75 ° F.

By comparison, at the time of the fall (November 22 and 23) mudpuppy survey, discharge was 4,220 cfs and gage height was 81.03 feet (844.03 m.s.l.). Secchi disk measured 48 inches. Air temperature was 38 ° F, and water temperature was 37 ° F.

The fall conditions were as expected with flows and temperatures reduced, and visibility increased. Discharge during the two study periods is shown in Figure 5.

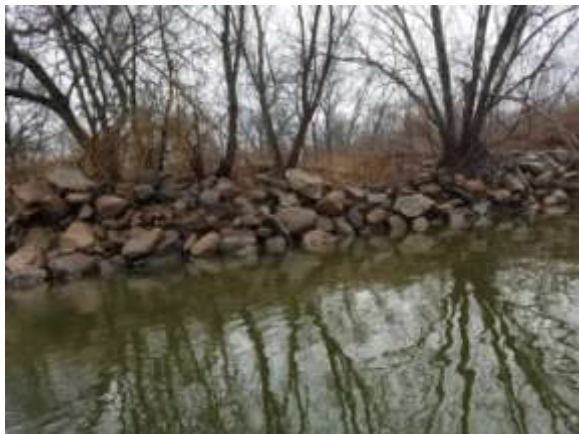
**West bank of the Cedar River
downstream of the Cedar Wapsi (C-57)
Bridge showing glacial boulders
_092050**

Based on these observations, we concluded that the best mudpuppy habitat was among the glacial boulders along the west bank. Marginal habitat was also present among the snags and woody debris at the upstream points of the bridge piers and along the east bank where there existed undercut banks among shoreline tree roots.

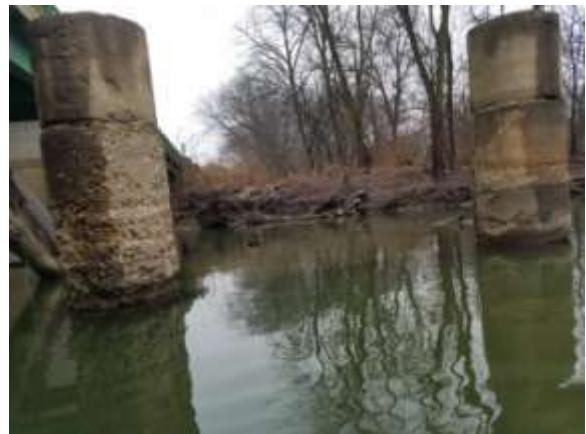
**East end of the Cedar Wapsi (C-57)
Bridge showing old pilings from a
previous bridge _092629**

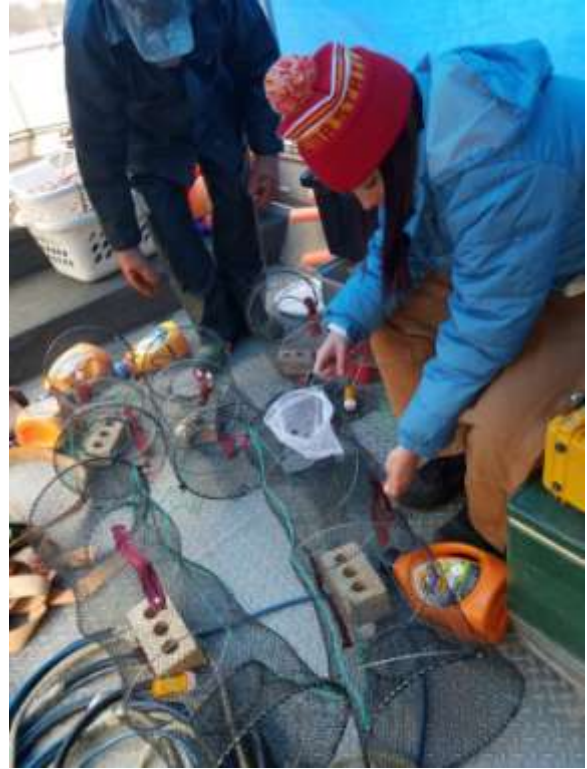
**Crew preparing traps to be set for
mudpuppies at the Cedar Wapsi (C-57)
Bridge_114718**

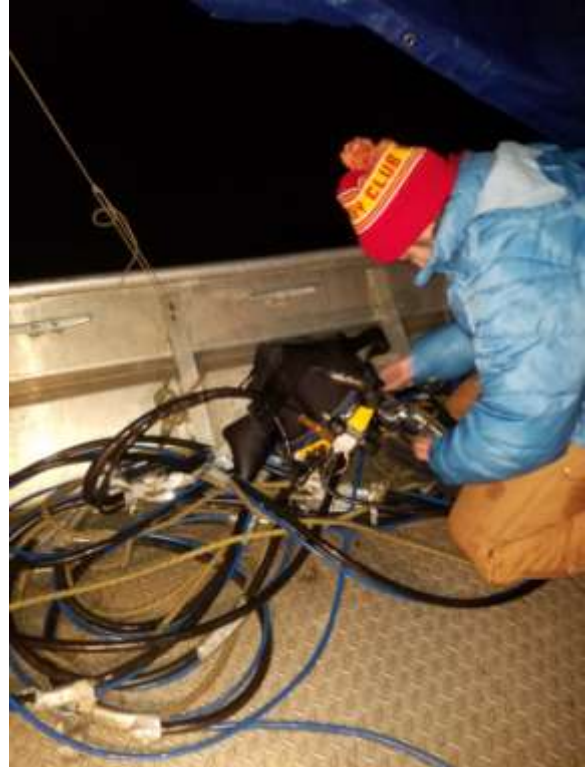
**Rigging camera for observing mudpuppies at the Cedar Wapsi (C-57)
Bridge_203350**

During the evening of November 22, we conducted night diving. For this procedure, the diver was equipped with lights and a GoPro Hero4 Black camera mounted on his dive helmet. The camera recorded continuously during the dive. The diver was also in continuous voice communications via on his umbilical line.
